**Flood Control Project Maintenance
Levee Inspections****LMA District Cover Sheet****Spring 2012 Levee Inspection Results****Sutter Maintenance Yard East-West Interceptor**

Spring 2012 Levee Inspection Results

Sutter Maintenance Yard East-West Interceptor

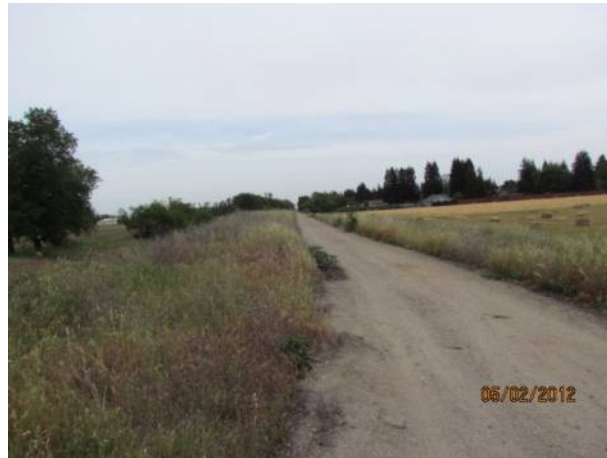
Levee Mile Report Line	5
Start Levee Mile	0.00
End Levee Mile	0.32
Location	Water Side
Category	Earthen Levee
Item	Vegetation

View of the vegetation along the W/S toe.

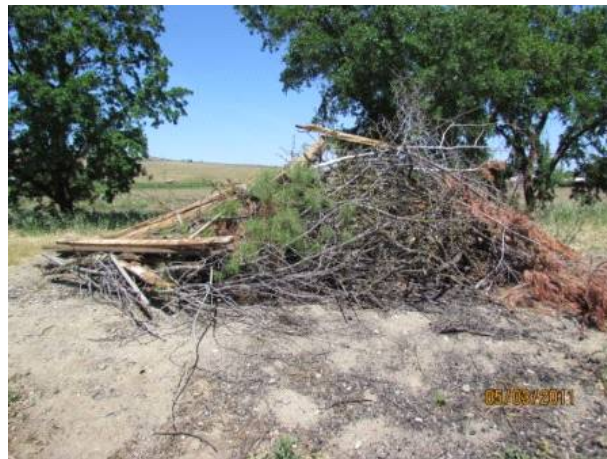
Levee Mile Report Line	6
Start Levee Mile	0.22
End Levee Mile	0.22
Location	Land Side
Category	Earthen Levee
Item	Encroachments

View of the pruning along the levee.

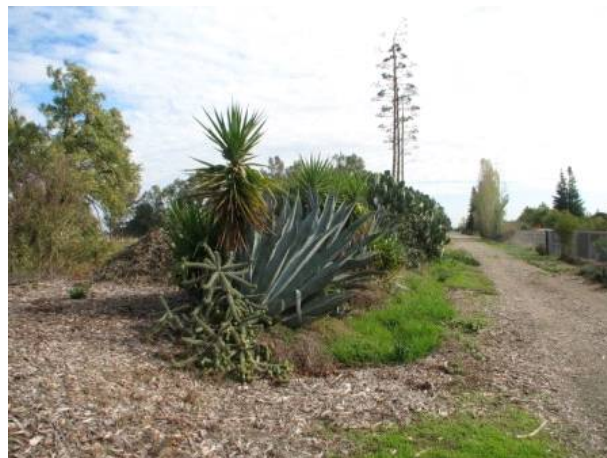
Levee Mile Report Line	7
Start Levee Mile	0.23
End Levee Mile	0.25
Location	Crown
Category	Earthen Levee
Item	Vegetation

View of cactus and pine trees along the land side toe.

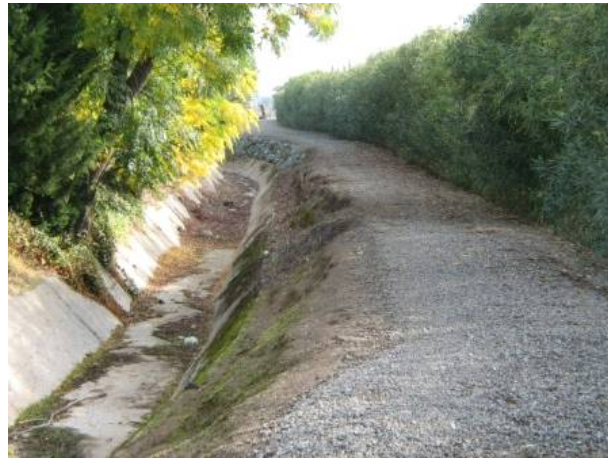
Levee Mile Report Line	8
Start Levee Mile	0.62
End Levee Mile	0.65
Location	Water Side
Category	Earthen Levee
Item	Erosion / Bank Caving

View of the erosion along the concrete ditch on the waterside slope.

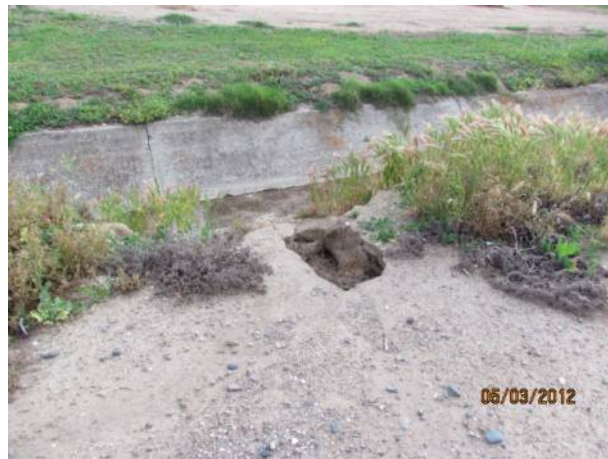
Levee Mile Report Line	9
Start Levee Mile	0.88
End Levee Mile	0.88
Location	Water Side
Category	Earthen Levee
Item	Erosion / Bank Caving

View of the erosion along the W/S toe.

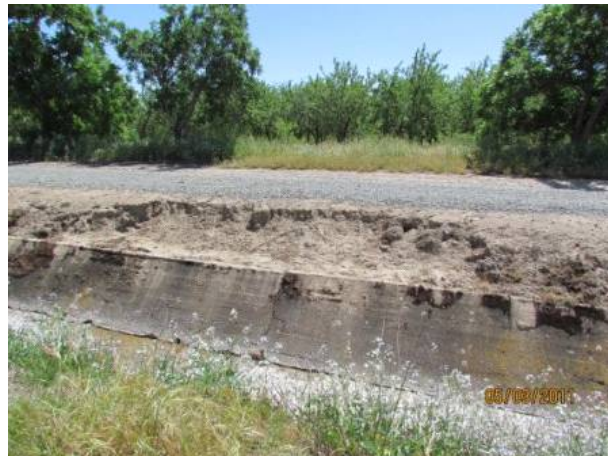
Levee Mile Report Line	10
Start Levee Mile	1.23
End Levee Mile	1.24
Location	Water Side
Category	Earthen Levee
Item	Erosion / Bank Caving

View of the erosion along the concrete canal.

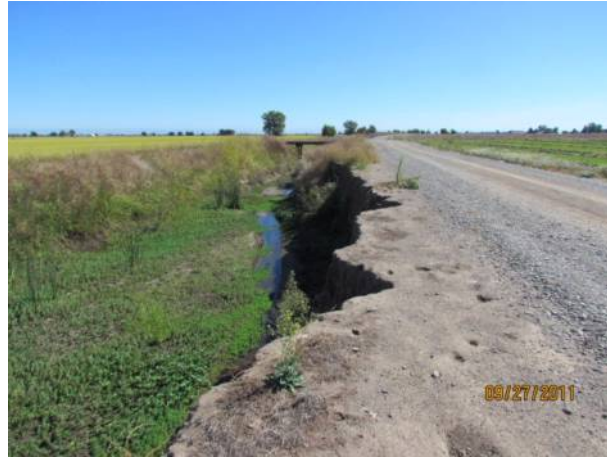
Levee Mile Report Line	11
Start Levee Mile	1.67
End Levee Mile	1.67
Location	Water Side
Category	Channels
Item	Erosion / Bank Caving

DWR ID: DWR_NA0020_01_s_2012_3									
11	1.67	1.67	Channels	Erosion / Bank Caving	WS M Ma	Inspector Comments: Sutter Yard needs to repair the channel.	39.171128 ° -121.729235 °	39.171128 ° -121.729235 °	6 Y
DWR ID: DWR_NA0020_01_s_2012_6

View of the erosion along the channel.

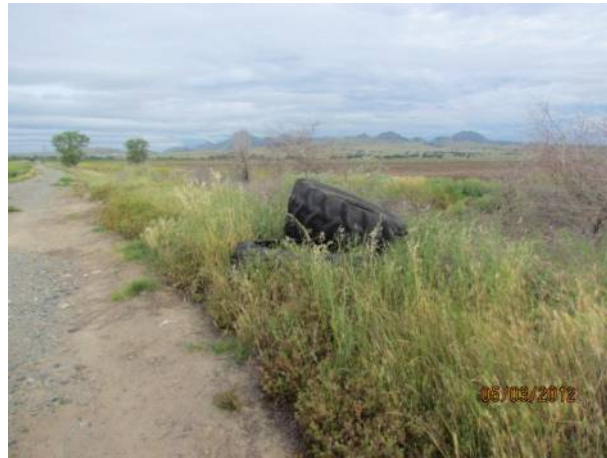
Levee Mile Report Line	2
Start Levee Mile	0.25
End Levee Mile	0.25
Location	Water Side
Category	Earthen Levee
Item	Encroachments

View of the tires along the W/S toe.

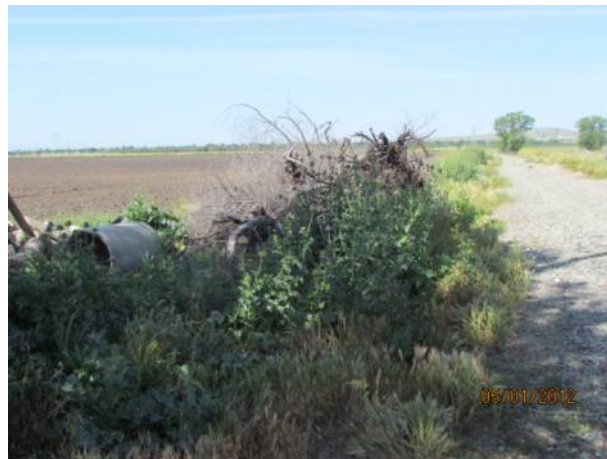
Levee Mile Report Line	3
Start Levee Mile	0.26
End Levee Mile	0.26
Location	Land Side
Category	Earthen Levee
Item	Encroachments

View of the debris along the L/S toe.

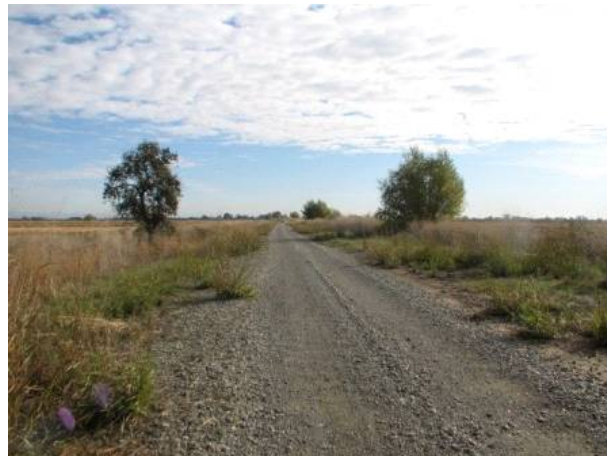
Levee Mile Report Line	4
Start Levee Mile	0.55
End Levee Mile	1.55
Location	Land Side
Category	Earthen Levee
Item	Vegetation

View of the grasses and vegetation on both slopes.

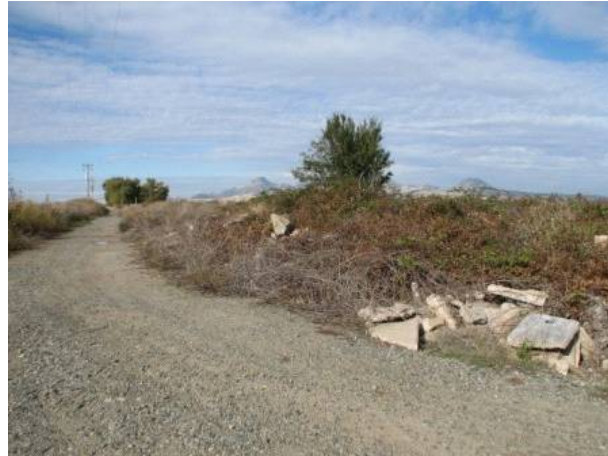
Levee Mile Report Line	6
Start Levee Mile	1.43
End Levee Mile	1.55
Location	Land Side
Category	Earthen Levee
Item	Encroachments
View of the pile of broken concrete next to the levee.	
rduffey_s_20120312_434.jpg

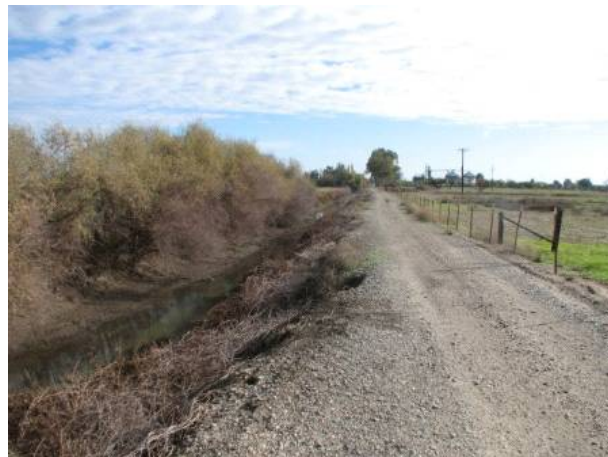
Levee Mile Report Line	7
Start Levee Mile	1.54
End Levee Mile	1.93
Location	Water Side
Category	Earthen Levee
Item	Erosion / Bank Caving
View of the erosion along the waterside slope.	
rduffey_s_20120312_435.jpg

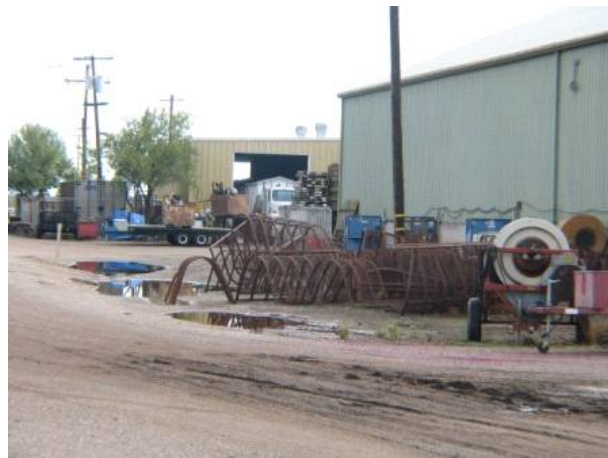
Levee Mile Report Line	8
Start Levee Mile	1.92
End Levee Mile	2.04
Location	Land Side
Category	Earthen Levee
Item	Encroachments
View of the equipment and buildings next to the landside berm.	
rduffey_s_20120312_436.jpg

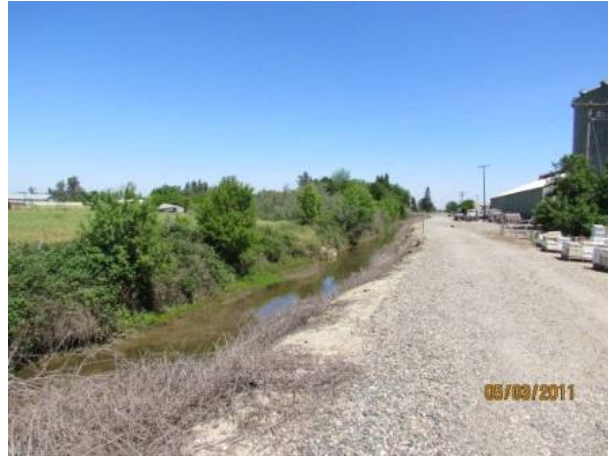
Levee Mile Report Line	9
Start Levee Mile	1.95
End Levee Mile	1.98
Location	Land Side
Category	Earthen Levee
Item	Erosion / Bank Caving

View of the erosion along the W/S slope.

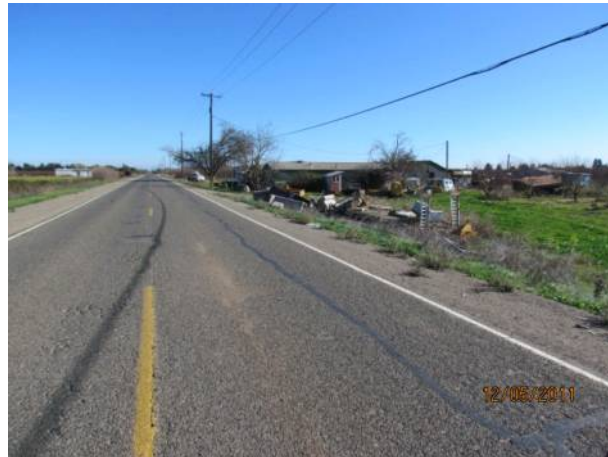
Levee Mile Report Line	10
Start Levee Mile	2.63
End Levee Mile	2.63
Location	Land Side
Category	Earthen Levee
Item	Encroachments

10	2.63	2.63	Earthen Levee	Encroachments	LS	M Ma	GA : Garbage	39.170543 ° -121.677402 °	39.170543 ° -121.677402 °	8 Y
DWR ID: DWR_NA0020_02_s_2012_8										
11	2.71	2.71	Earthen Levee	Encroachments	LS	M Ma	MA : Material	39.170548 ° -121.675970 °	39.170548 ° -121.675970 °	10 Y
DWR ID: DWR_NA0020_02_s_2012_10

View of debris & garbage along the L/S toe.

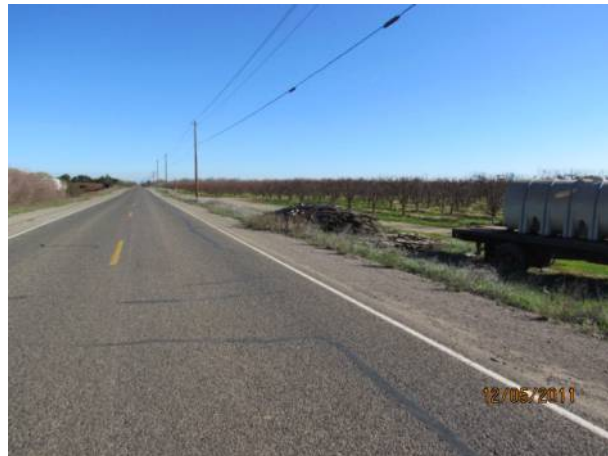
Levee Mile Report Line	11
Start Levee Mile	2.71
End Levee Mile	2.71
Location	Land Side
Category	Earthen Levee
Item	Encroachments

View of material, garbage & equipment along the L/S toe.
